# Manhole Inspection Summary

Manhole # S09CC1016MH

Insp Date: **7/5/07 11:28 AM**

**Location** Address: **3902 BAREVA RD** Cross Street: **DOLFIELD AVE**

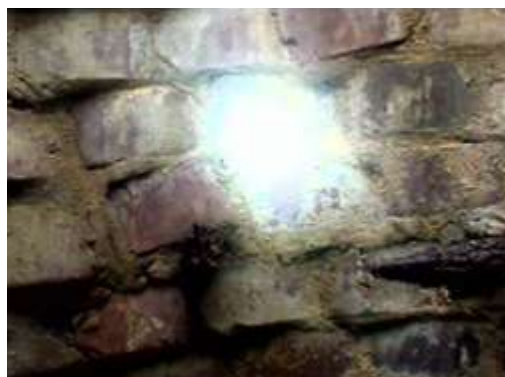
Defect 1

**Steps** Count: **3** Missing: **1** ☒ **Corroded**

MISSING/CORRODED RUNG

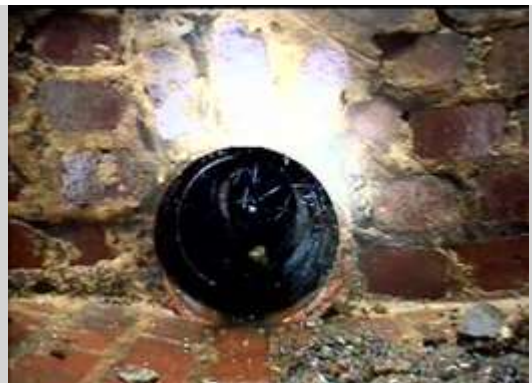
12 O'Clock Outflow

8 in. Circular Gravity Sewer  
Pipe Out @ 12 O'Clock

Pipe Material: **Clay** ☐ Pipe Lined

Invert Depth: **7.35** (ft.) Flow Characteristics: **None**

Infiltration: **None** Pipe Seal Cond: **Sound**
